## Back yard battery desulfation with special chargers:

I have several commercial battery chargers which were unable to charge this 6 cell 12v battery which was headed for the tip. I made my own charger and here are the results.

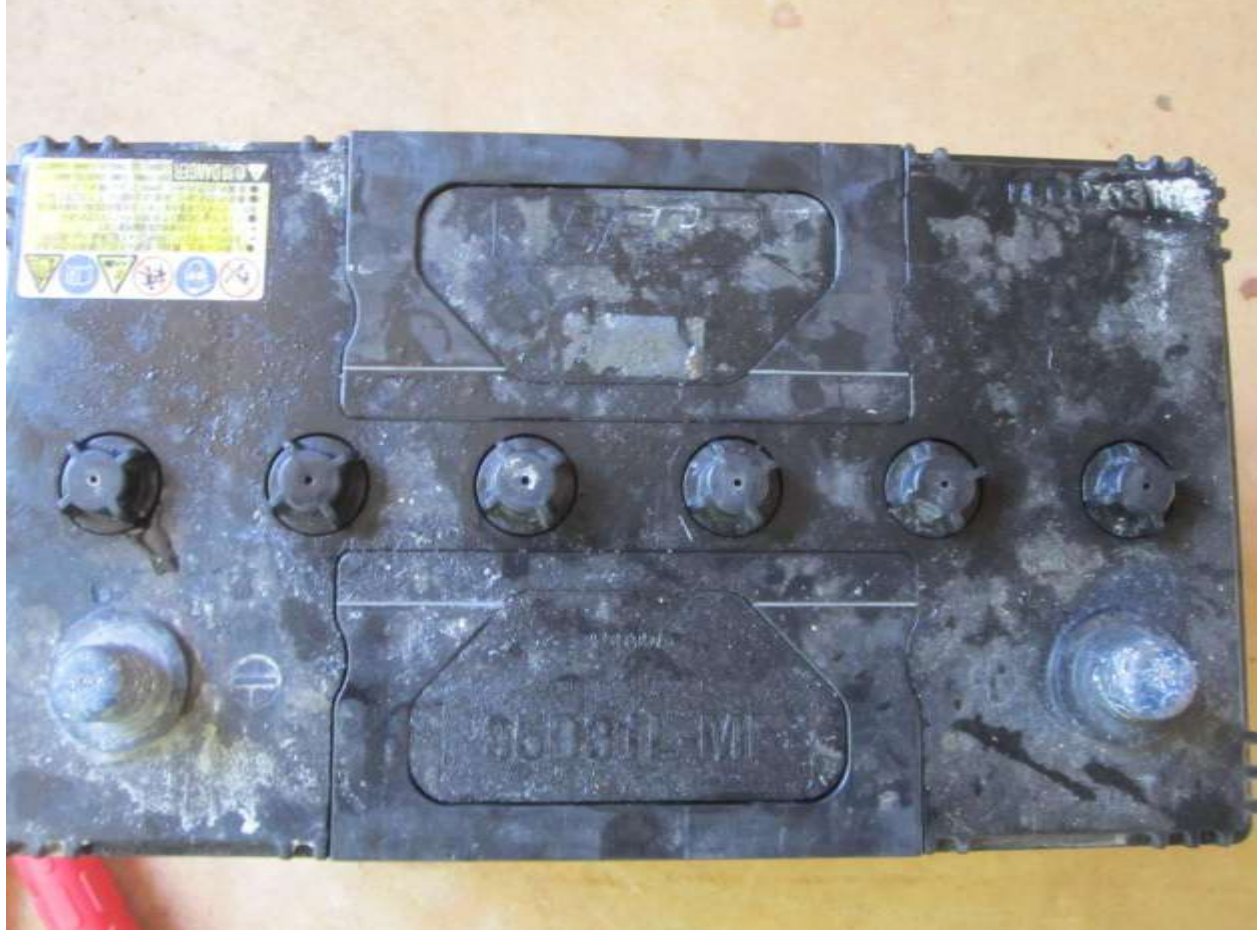
Originally the battery would register a surface charge but this would not affect the specific gravity of the battery. The batteries plates were completely sulfated and the charging current was minimal.

After charging with my charger the cells registered an improvement reading around 13.00 however the electrolyte level was low and after topping up registered below 12.00.

Once reconnected to my special charger for approximately 2 days the plates showed as nice brown colour and had lost their sulfation coating. However cell 4 is bad and hasn't registered much improvement.

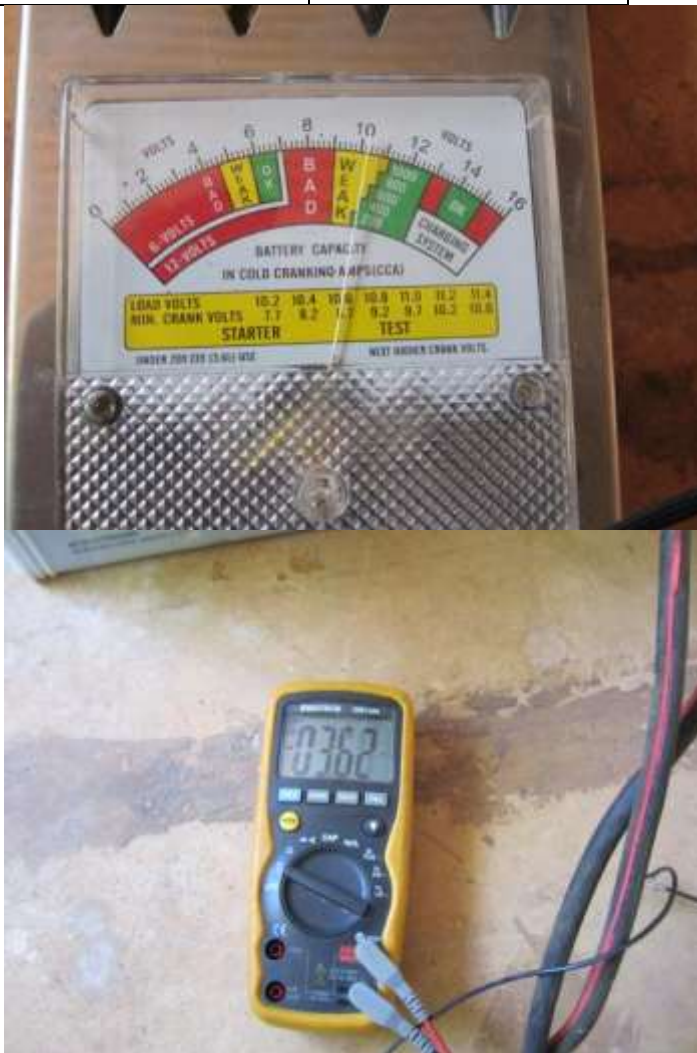
Below are approximate CCA readings. One is with a commercial unit which I rewired after it caught on fire, the other is with a unit I made that uses a shunt to measure amperage. The shunt is about +/-10% accurate. This readings show the battery improving after each lot of desulfation.

| 400CCA 20s stable | 3.62v – 3.26v<br>(multiple by 98 =<br>354A to 319A) 10<br>second load |

I did not have the CCA tester before I recovered this battery so I do not know the original CCA of the battery. I have recovered other maintenance free batteries but cannot access more than one cell for voltage and specific gravity reading.
