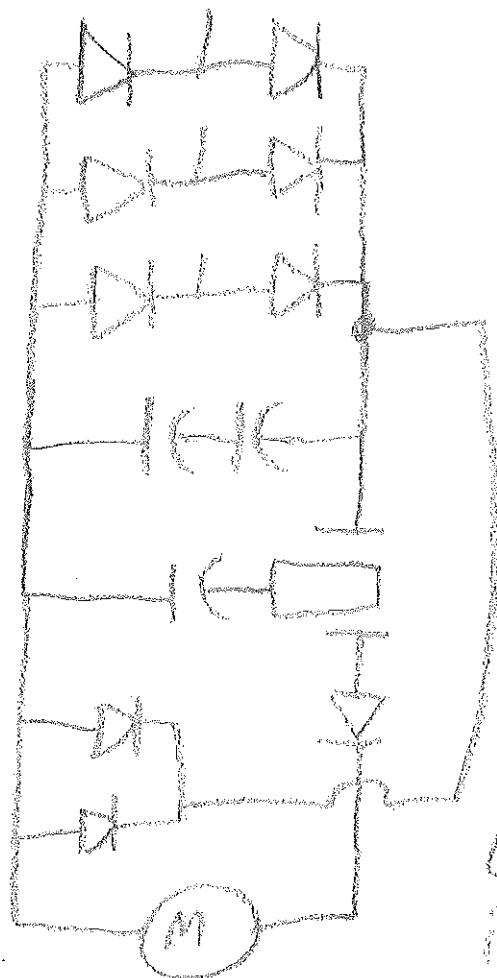
From  
alternator

2 alternator  
capacitors  
in series

Removed  
line diode between  
capacitor & switch

Back EMF to  
alternator capacitors  
instead of  
switch capacitors
